GUIDE FOR ENGINEERINGS AND END USERS

HOW TO SPECIFY GRAPHITE HEATER OR COOLER FOR PICKLING APPLICATIONS Pickling lines & ARP

Graphite Technology
CORROTEC

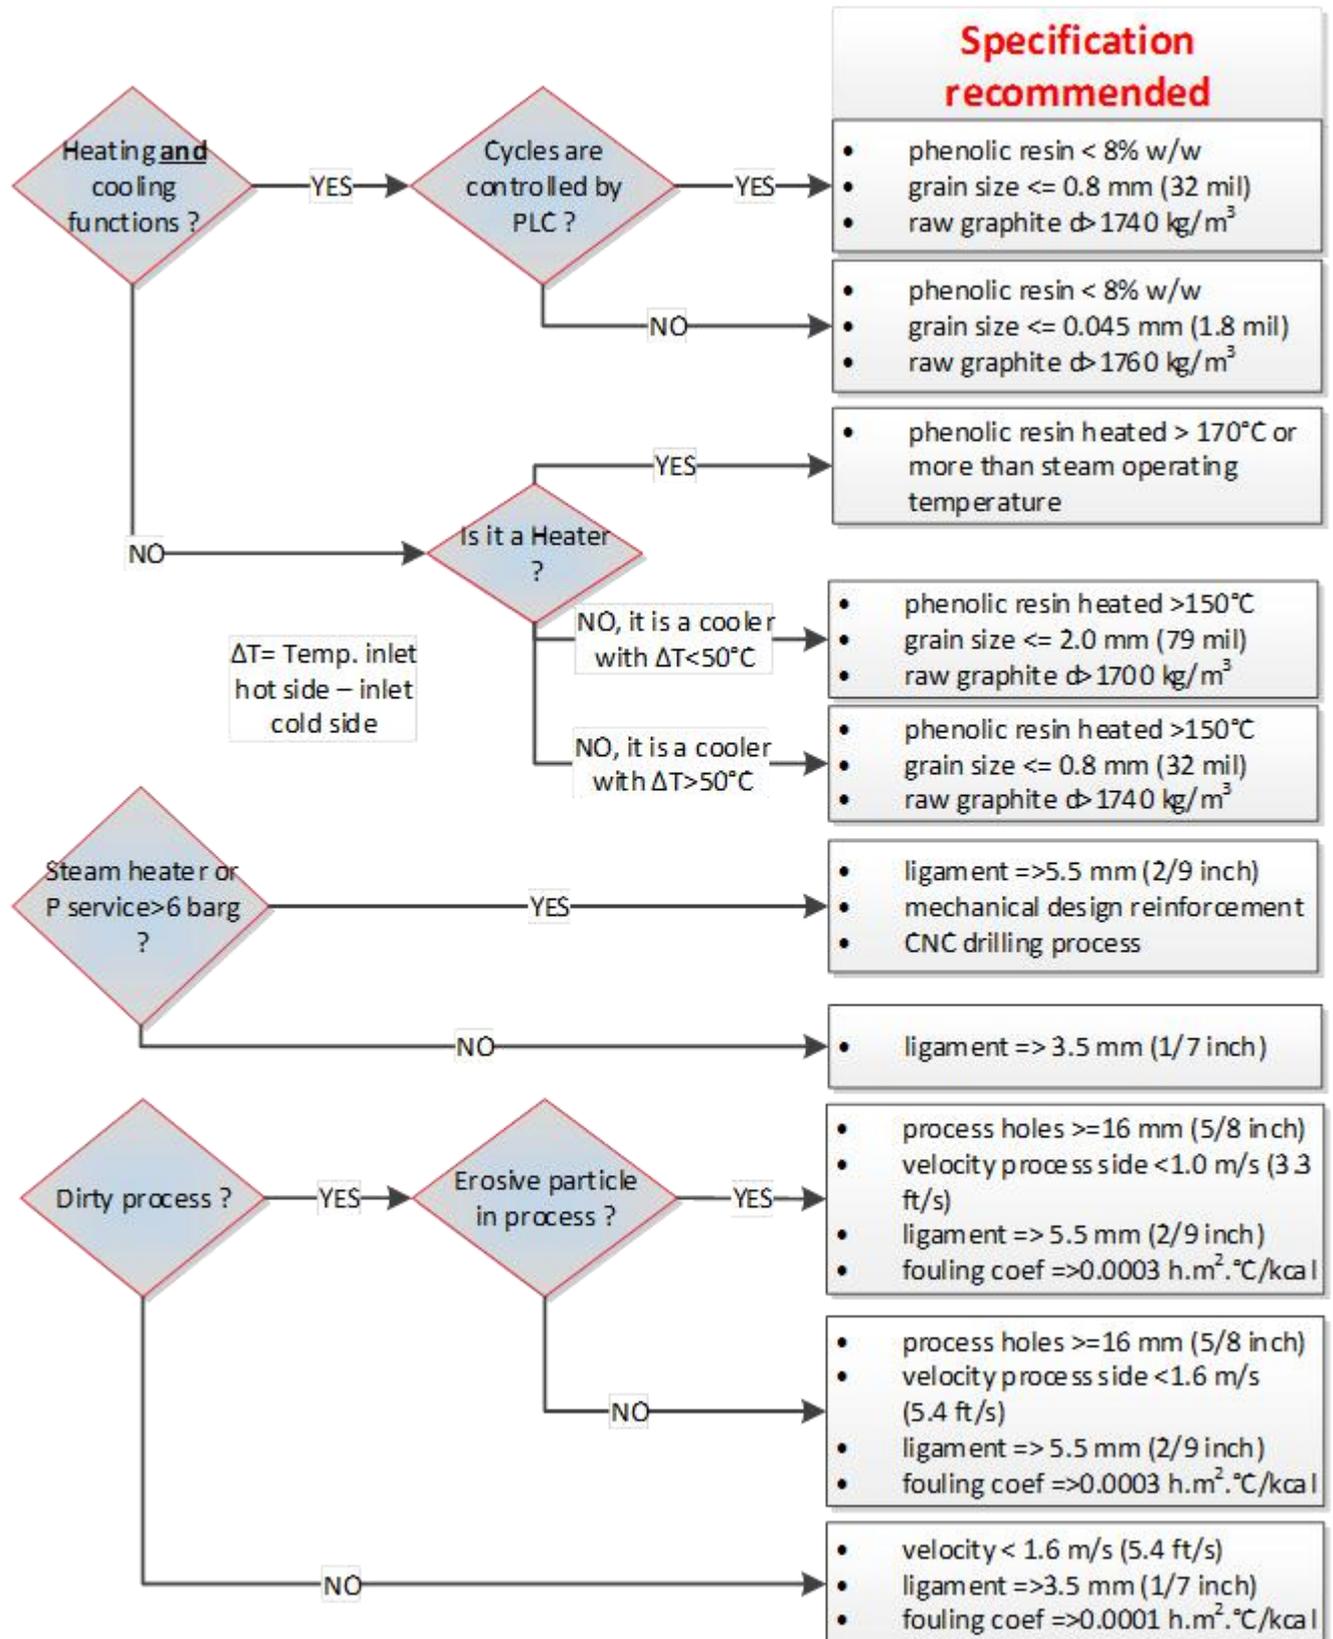
2. Carbon steel pickling

The values to specify could be found in the following page according to a flow chart of simple questions.

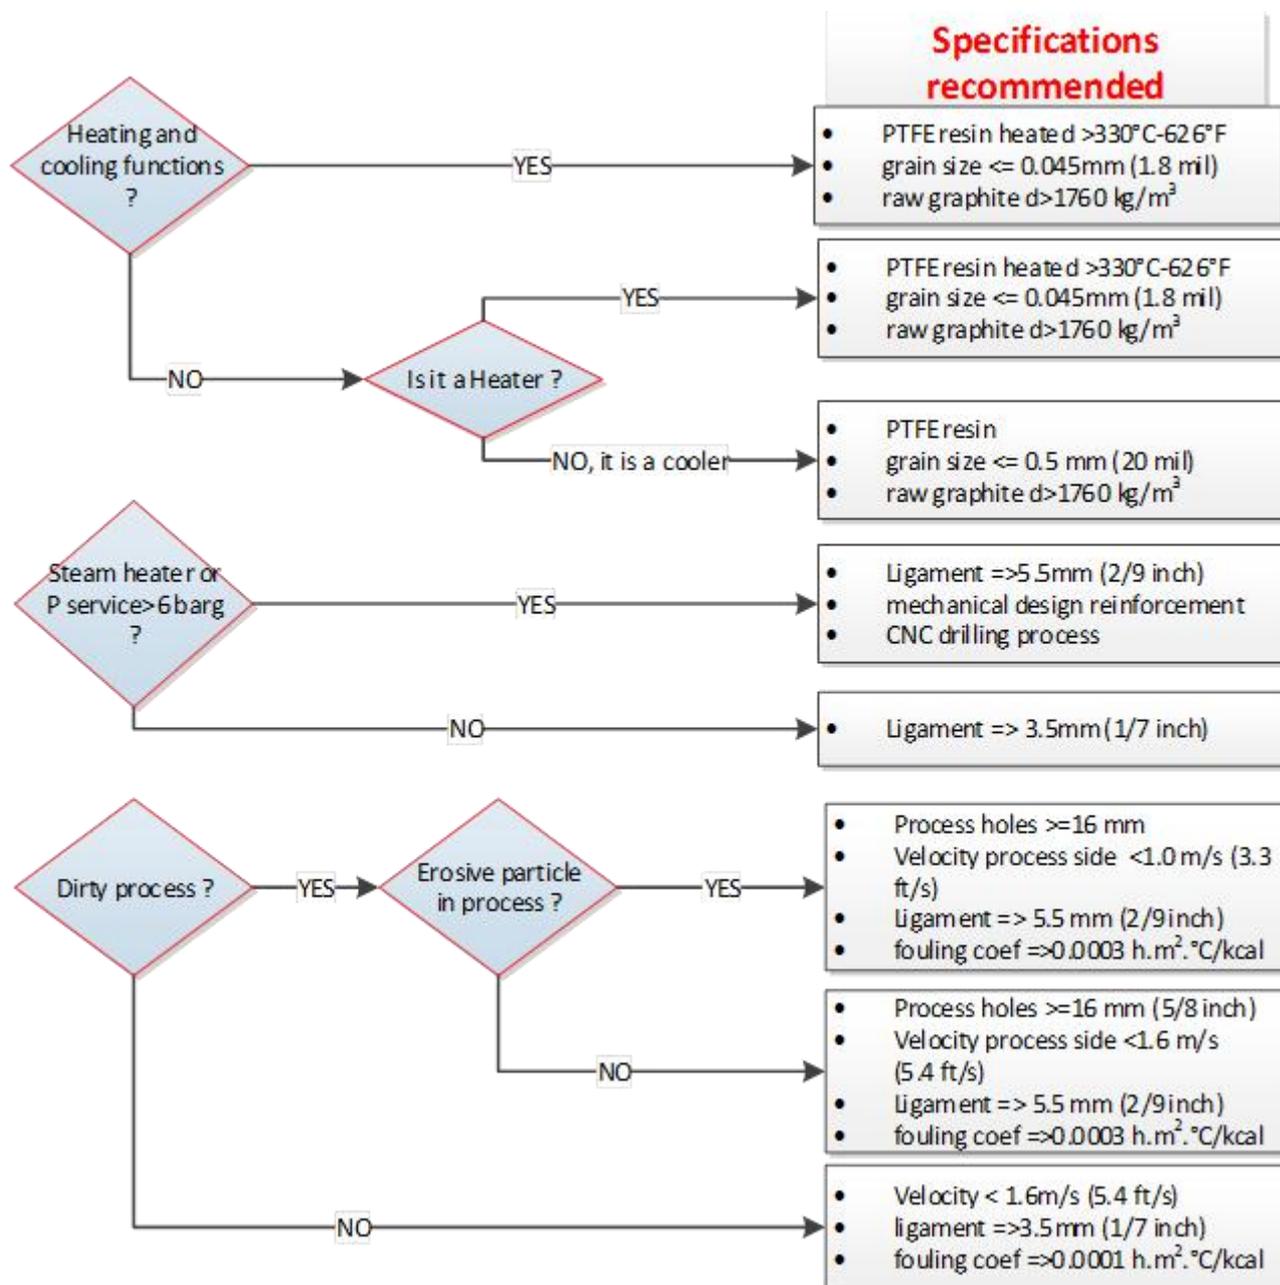
3. Stainless steel and alloys pickling

Such process is not compatible with phenolic resin impregnation. Consult us for corrosion resistance compatibility guidance.

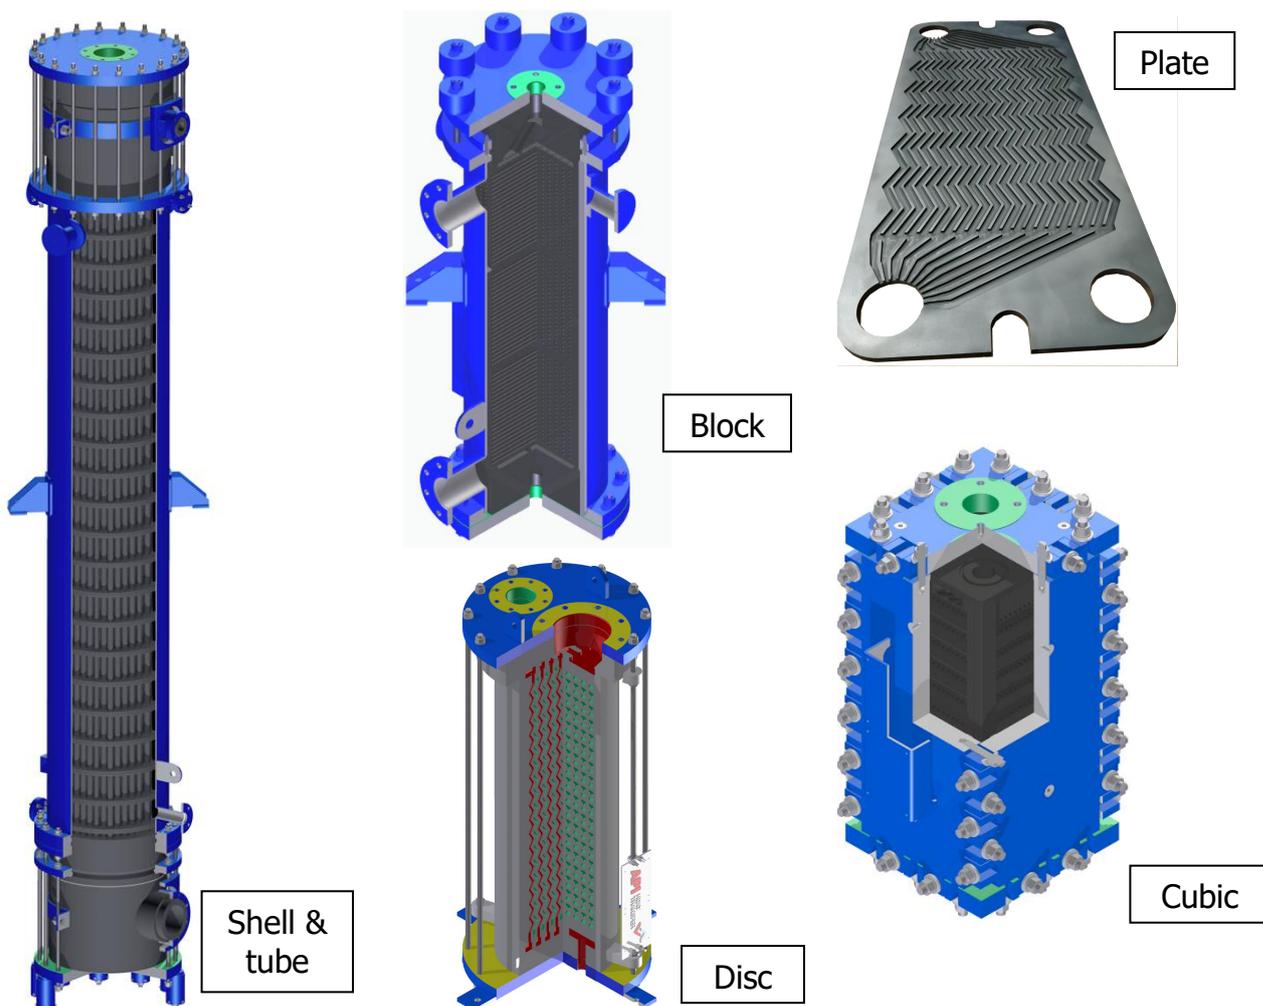
4. Type of heat exchangers to select

Hereunder, a selection of models of heat exchangers more adapted for your process based on few operating parameters.
